June 8, 2014

Mr. Forrest Siebken
City of Milford
505 1st Street
Milford, Nebraska 68405

RE: **City of Milford Building
Roof Observation Letter**

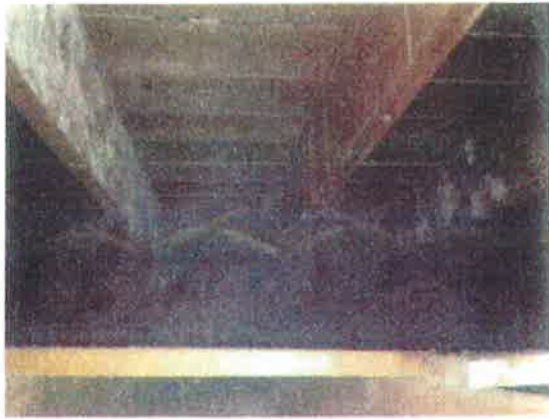
Original Building Roof & Ceiling Joist

In observing the existing roof structure in the original building, 1x decking was supported by 2x10 joist, clear spanning the building east/west, at 1'-4" o.c. Insulation screws were observed penetrating the 1x decking along with wood cross bracing providing lateral support for the joist. Some efflorescence was observed on the masonry walls, however the joist bearing locations appeared to be in good condition. 2x8 ceiling joist, spanning east/west at 1'-4", supported the original wood lath and plaster ceiling system along with a newer acoustical tile ceiling system.

Using the required ground snow load from the IBC 2009 for the area, a snow roof live load was determined and an appropriate dead load was assigned to each area. For any member to pass the design standards they must meet both the stress requirements for load and the serviceability requirements of allowable deflection according to the type of load. The roof joist in the original building are currently 25% overstressed and do not meet the serviceability deflection requirements. Remedial action to correct this would be to sister another joist alongside these joist or place a kicker, at a 45 degree angle, from the ceiling joist bearing point to the roof joist to cut down the span. The ceiling joist in this area meet the required stress for amount of load, however they are currently failing the deflection criteria. Remedial action would require the removal of the lath and plaster system or the sistering of another joist to the current 2x8.

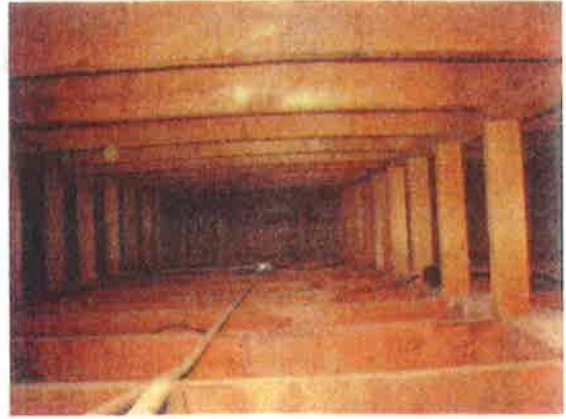
1st Add. Roof & Ceiling Joist at Corridor Wall

The first addition roof structure was similar to the original building, however additional support was provided to the roof and ceiling joist by the interior load bearing hallway walls. 2x6 roof and ceiling joist were spanning east/west at 1'-4" o.c. Each were supporting the same secondary systems with the only difference being at the ceiling joist. Instead of the lay-in acoustical tile ceiling system, wood furring had been attached to the plaster and fiber tiles were attached for the ceiling system.

At the 1st addition the roof and ceiling framing meet the load and deflection requirements. Since the hallway walls provide interior support for the roof and ceiling, this load is transferred down to the 2x12 floor joist. A few of the floor joist on the north side of the addition, prior to the west clay tile wall providing addition support would need to be reinforcing with the sistering of another joist alongside the existing 2x12's.

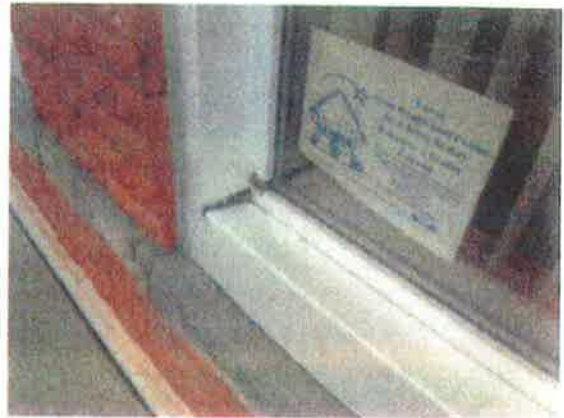
Window at North Exterior Wall

At the window in the north exterior wall, it is my opinion that the window did not have adequate backing behind the flashing recess. In reviewing this area, the flat flashing

portions can easily be depressed and that there are openings in the sealant and caulking that are allowing the moisture to get inside the masonry wall. This area should be repaired so to prevent the further infiltration of moisture.
